AN EVALUATION OF THE PERFORMANCE OF
ZRC COLD GALVANIZING COMPOUND
AS WELDING REPAIR PER ASTM A 780 ON
G90 HOT-DIP GALVANIZED STEEL
IN 5% SALT SPRAY

Date: January 30, 2009

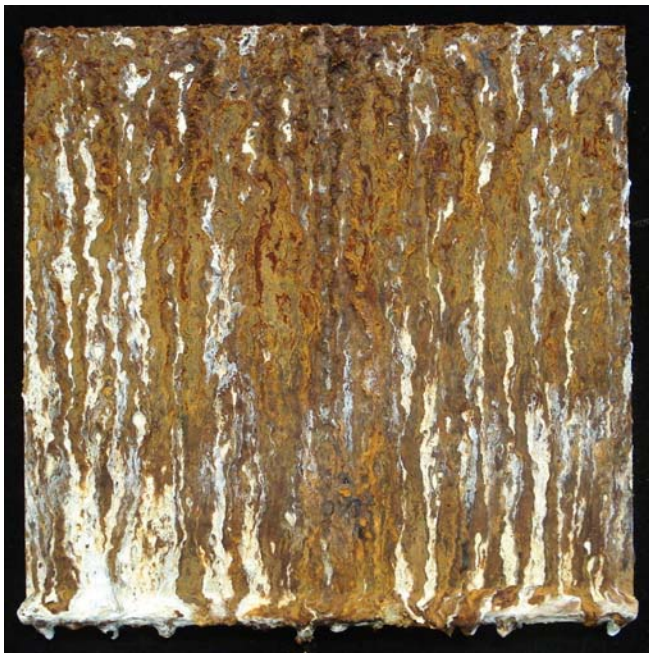
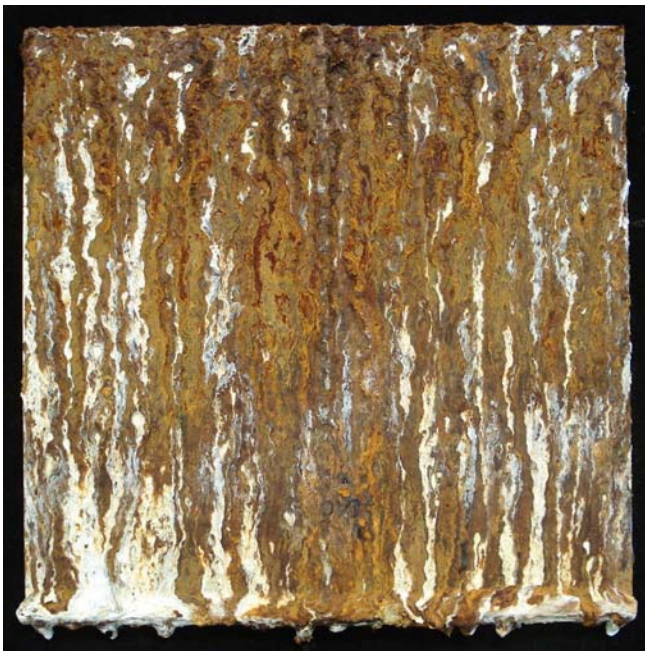
Showing the control test piece after 1500 hours ASTM B 117 Salt Fog Testing.

Figure 1 shows the condition of our control test piece, which received no surface preparation before testing. After 1500 hours of salt fog testing, it has formed copious amounts of zinc salt on its surface as a result of the galvanic reaction caused when zinc sacrifices itself to protect the underlying substrate. However, it has also begun to exhibit a significant amount of red rust across its surface, ASTM D 610 Rust Grade 2-G. The weld itself is totally corroded.

The results of this evaluation illustrate that ZRC Cold Galvanizing Compound affords outstanding protection against corrosion to welded and/or damaged areas of G90 hot-dip galvanized steel. Figure 2 shows the condition of the ZRC Cold Galvanizing Compound coated test piece after 1500 hours of ASTM B117 Salt Fog Testing. Figure 1 shows the galvanized control test piece without ZRC applied.

Figure 1

Showing the control test piece after 1500 hours ASTM B 117 Salt Fog Testing.

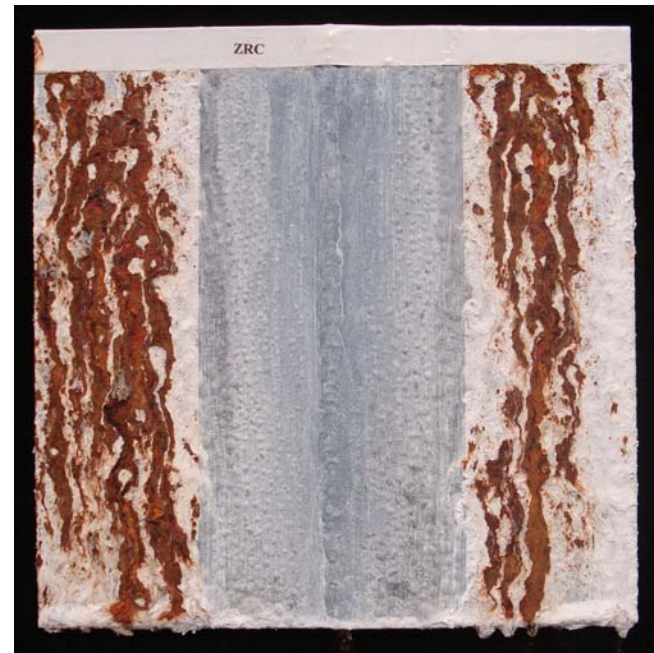
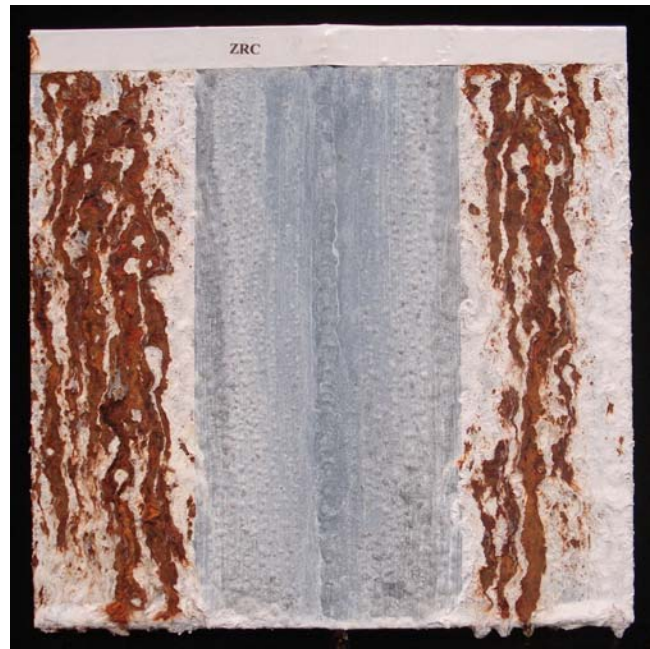
Showing test piece with ZRC applied after 1500 hours ASTM B 117 Salt Fog Testing.

Figure 2 shows the condition of the ZRC Cold Galvanizing Compound coated test piece. On the uncoated area of the hot-dip galvanizing, similar to the control test piece, this panel has also formed copious amounts of zinc salt, accompanied by red rust, ASTM D 610 Rust Grade 3-G.

However, where ZRC has been applied to the weld and surrounding area, there is no rust, only light formation of zinc hydroxycarbonate salt, typical of bonafide zinc rich coatings. The weld shows no corrosion at all. No blistering was observed on the weld and the surrounding coated area. Light blistering was observed at the interface between ZRC and the uncoated hot-dip galvanizing, ASTM D 714 6-MD, seemingly caused by the formation of the copious amounts of zinc salt on the uncoated area bleeding over.

Figure 2

Showing test piece with ZRC applied after 1500 hours ASTM B 117 Salt Fog Testing.

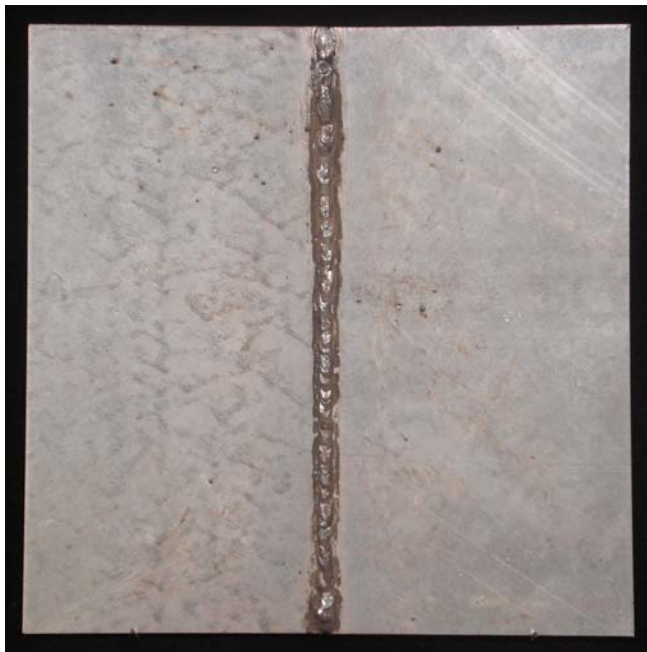
In this experiment, 11 gauge panels of G90 specified hot-dip galvanized steel (ASTM A 526) were obtained from Ledford Steel Company, Winchester, KY and employed as the substrate. Two panels of the substrate were MIG-welded together to create the test area. Figure 3 shows the test piece after welding. The welded area was then Power Tool Cleaned (SSPC-SP 11). The surrounding area was Hand Tool Cleaned (SSPC-SP 2). The surface of the whole test piece was then Solvent Cleaned (SSPC-SP 1) using MEK. Figure 4 illustrates the test piece after cleaning.

Figure 3
Showing a representative
test piece after MIG welding.
